Tradename: ProCutiGen® Bond

Test Performed:

Scanning Electron Microscopy (SEM)

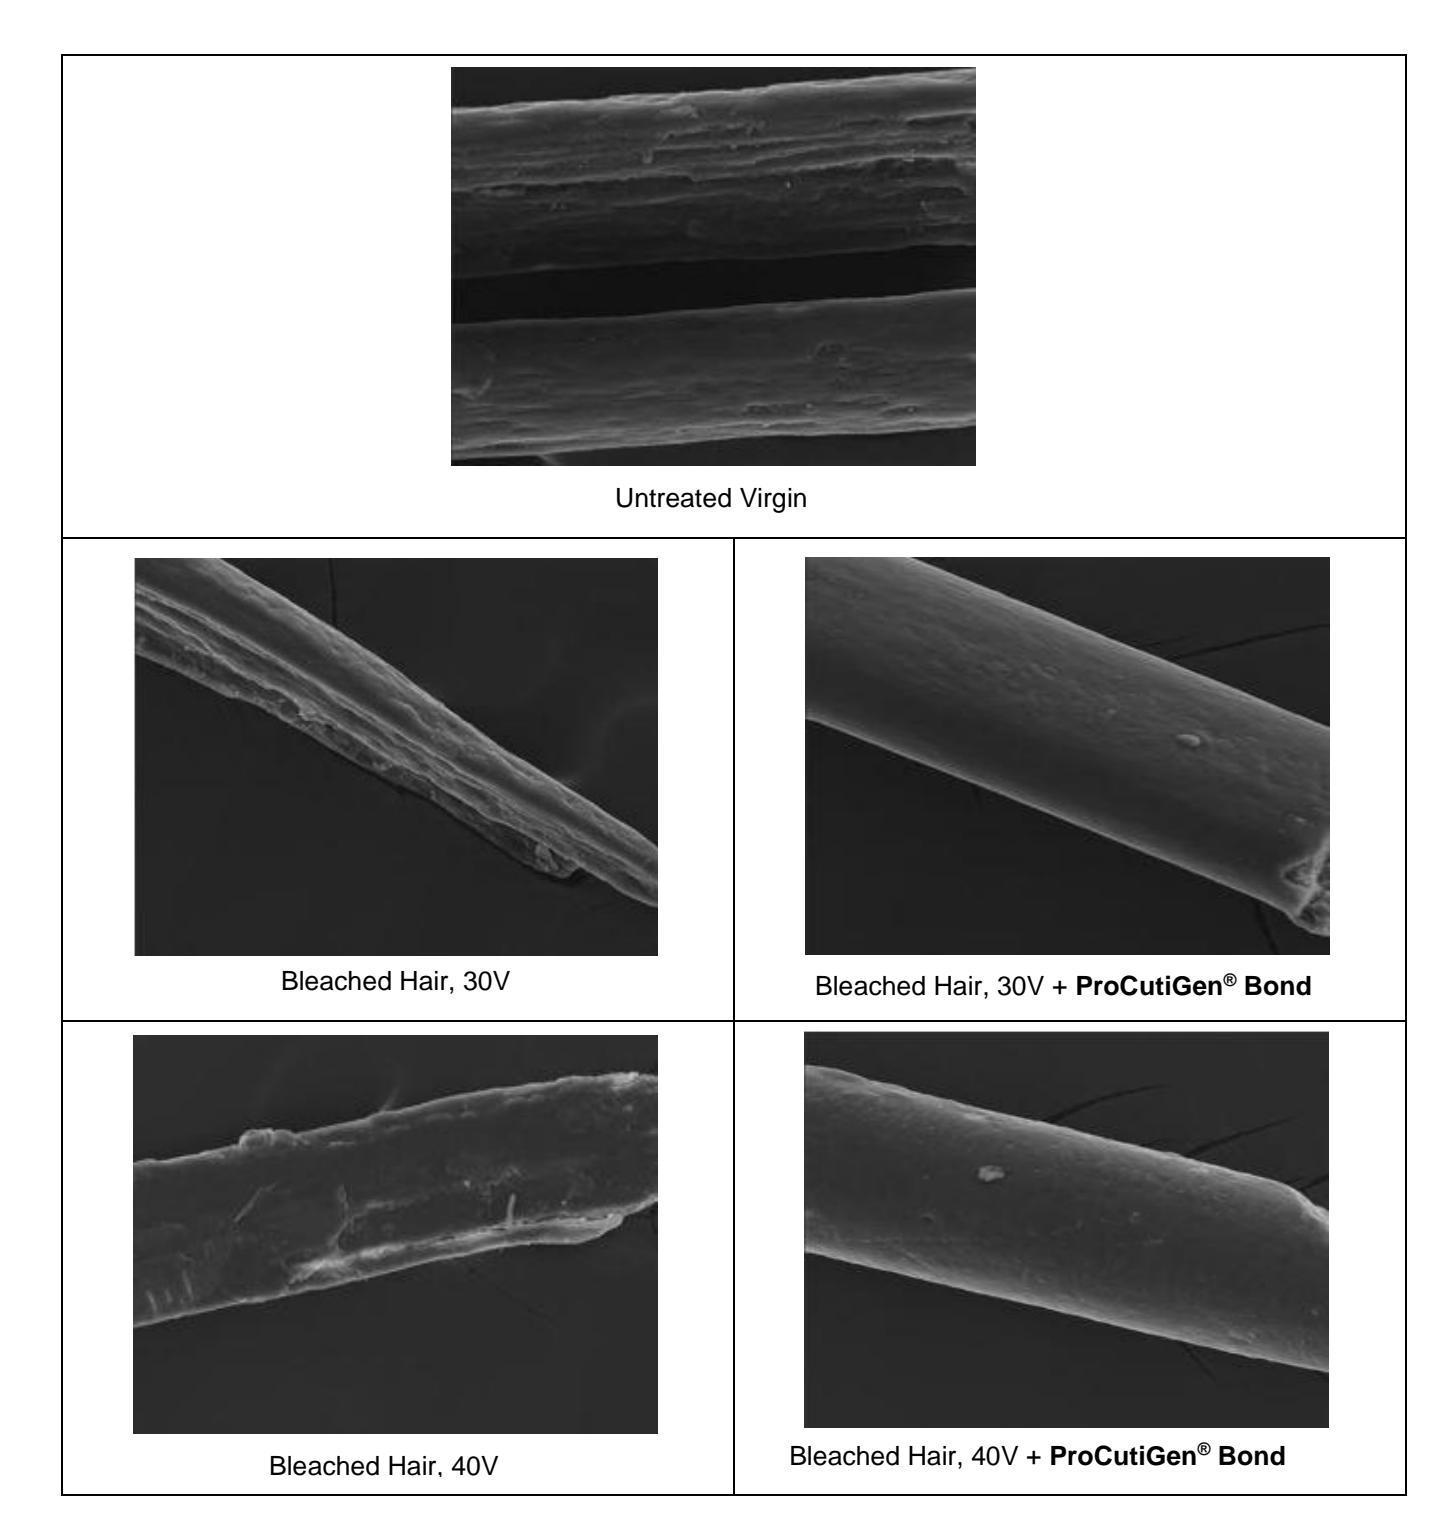
Results

Gaston College Textile Technology Center located in Belmont, North Carolina was asked to perform Scanning Electron Microscopy Imaging (SEM) on the five hair swatches provided by Active Concepts, LLC. Gaston College used a Zeiss DSM 962 to perform the test at 20.0kV using a magnification range from 50x-300x. This method utilizes an electron microscope that produces images a chemically treated hair by scanning the hair with a focused beam of electrons. These electrons interact with the atoms of the hair sample to provide images of the hairs surface topography and surface composition.

Standard Electron Microscopy (SEM) imaging shows high resolution images of the hair cuticles of each hair swatch. The SEM images depict how the outermost layer of the hair, the cuticle, is effected by chemical treatments (bleach & relaxer). The SEM imaging demonstrates that, untreated virgin hair is clearly already prone to damage from everyday aggressors, showing characteristic signs of breakdown, pre chemical treatment. The treated alone imagery results depict an extensively damaged cuticle. This type of damage leads to irregular growth, breakages, and overall unhealthy, dead appearance. At a singular level, one cuticle may not seem important, but these strand to strand imperfections contribute to a much bigger picture of unhealthy and unprotected hair. When the untreated images are compared to both the **ProCutiGen® Bond** treated SEM images depict the creation of a de-novo cuticle on the damged cuticle. The cuticle corrects and acts as a protective cuticle to the fiber. The cuticle formation **ProCutiGen® Bond** employs also exhibits properties such as moisturization, pH balance, barrier protection, and additionally, protection from hair weakening after exposure to bleach rendering **ProCutiGen® Bond** the ideal addition to any bleach treatment or everyday treatment to repair and protect against everyday stressors.
